# Experimental study on High strength One-side bolted joints

**ABSTRACT:** High strength one-side bolts, which enable construction only from one side, are effective for repairing or strengthening closed-section members or for connecting steel pipes as joints. In this study, experiments were conducted to verify the fatigue strength and other basic characteristics of high strength one-side bolted joints. As a result, it was revealed that high strength one-side bolted joints have fatigue design curve to those of joints using conventional high strength bolts. Also presented in this paper are case studies of application of high strength one-side bolted joints to strengthening of steel truss bridge and arch bridges.

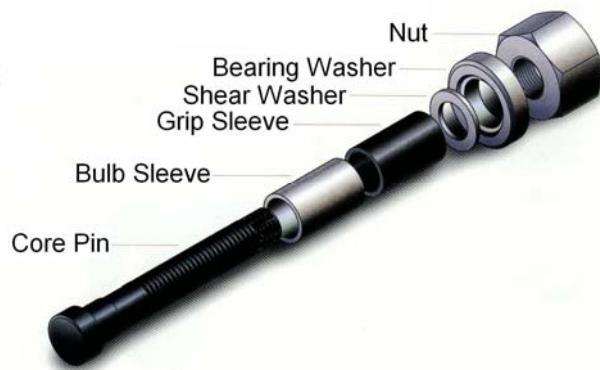
Figure 1. Components of High Strength One-Side Bolt

Six parts constitute OS-Bolt: bulb sleeve that forms the bolt head behind the member, shear washer and grip sleeve that support the bulb sleeve, bearing washer that secures the grip range, core pin with a special trapezoidal screw and nut. OS-Bolt are used in all kinds of steel structures for repairing bridges. Members can be fastened from one side using a dedicated electric shear wrench regardless of the field environment or human skill. Strength equivalent to F8T can be secured by high strength bolt for friction joint.

The components of OS-Bolt are shown in Figure 1.

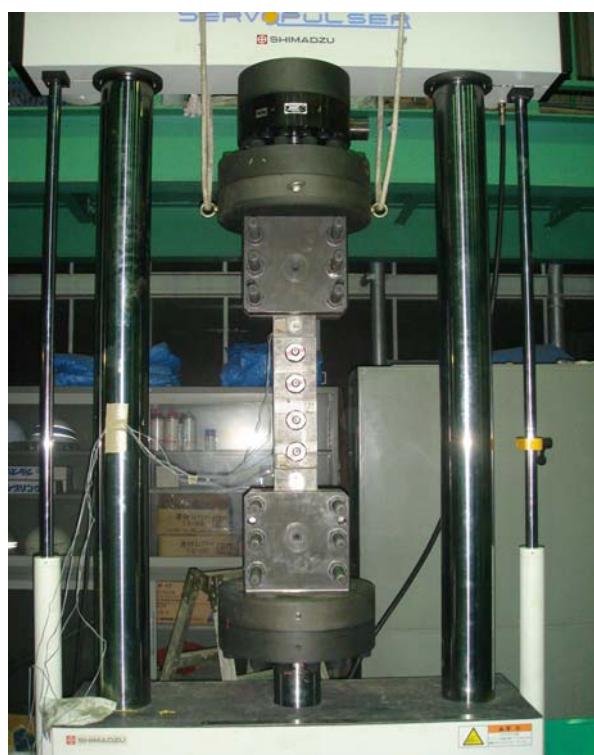
Photograph 4. Fatigue experiment

In the fatigue test, an electro hydraulic servo test machine in Photograph 4 was used for pulsating tensile fatigue test. Tension was applied cyclically at a rate of 6 Hz. The Tests were repeated until the fracture of the base plate with the maximum number of cycles set at 10 million times. The mechanical properties of steel plates are listed in Table 4. The materials of OS-Bolt ( $\phi 24$ ) and the mechanical properties of core pin are shown in Tables 5 and 6, respectively.

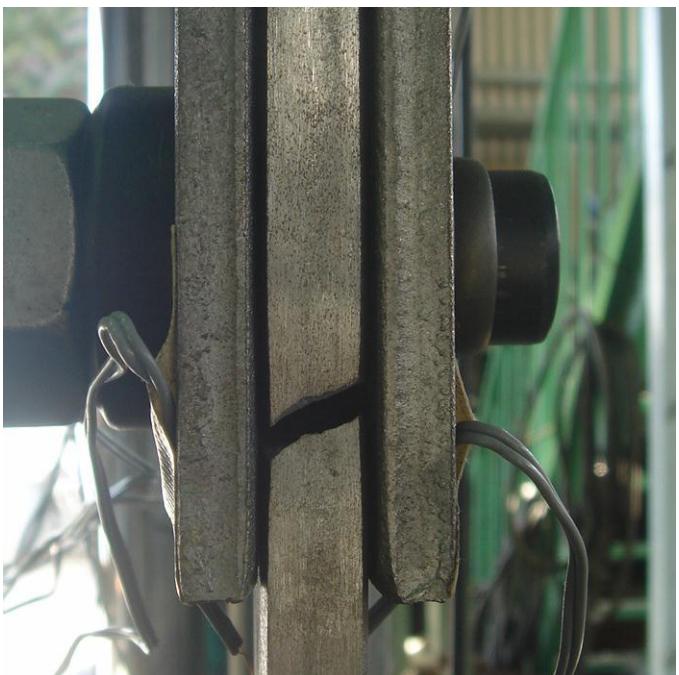
Photograph 6. Fracture of base material (M3)

In specimen M1, the base plate did not fracture until the number of cycles reached 10 million. Then, the test was discontinued. The base plate fractured from around the bolt-hole along the width of the plate after approximately 4.95 million cycles in specimen M2 and after approximately 5.00 million cycles in M3. The state right after the fracture is shown in Photographs 5 and 6 for M2 and M3, respectively.

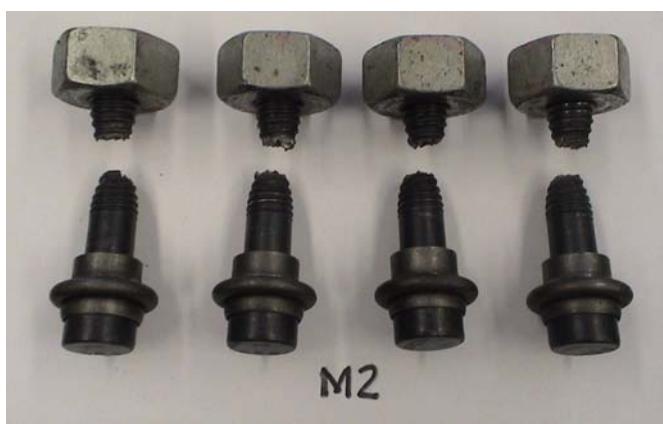
In order to verify the strength of the OS-Bolt ( $\phi 24$ ) after the fatigue test, specimens M2 and M3 were dismantled and tensile tests were conducted for bolts. The results of tensile tests for OS-Bolt at the time of shipment and after the fatigue test are shown in Table 7. Photographs 9 and 10 show how the bolts fractured.

After the tensile test, OS-Bolt all fractured at the screw of the bolt. It is therefore evident that the bulge (bolt head) that was deformed had sufficient strength. Tensile strength remained unchanged after the fatigue test. It was verified that no strength reduction occurred in OS-Bolt after cyclic loading was applied approximately five million times.

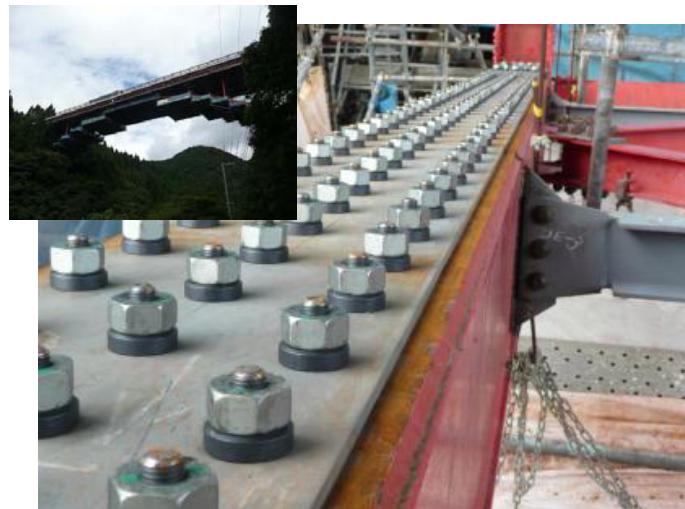
OS-Bolt has been frequently used for repairing or strengthening steel bridges under construction constraints. In recent years, OS-Bolt has been adopted in an increasing number of cases for seismic retrofit of relatively large bridges such as arch bridge and truss bridge. The example is strengthening steel bridge of arch rib in Photograph 11 and 12, 13 and strengthening steel truss bridge in Photograph 14.

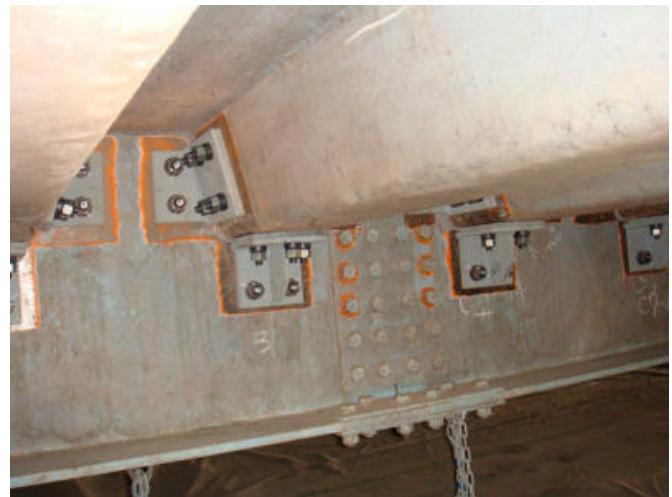
Photograph 15. Strengthening a U-Rib of steel slab

An example of connecting a strengthening member on a U-shaped rib of a steel slab using OS-Bolt is shown in Photograph 15.
