Basic Characteristics of High Strength One-Side Bolted Friction Joints

High strength one-side bolts, which enable construction only from one side, are effective for repairing or strengthening closed-section members or for connecting steel pipes as joints. In this study, experiments were conducted to verify the fatigue strength and other basic characteristics of high strength one-side bolted friction joints. As a result, it was revealed that high strength one-side bolted friction joints have fatigue design curve to those of joints using conventional high strength bolts. Also presented in this paper are case studies of application of high strength one-side bolted friction joints to box steel pipe columns and of seismic retrofit of steel truss and arch bridges.

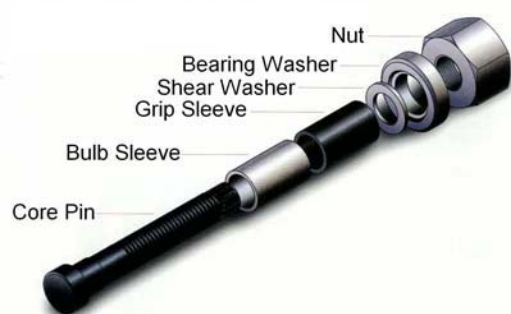
The components of a HOB are shown in Figure 1. Six parts constitute a HOB: bulb sleeve that forms the bolt head behind the member, shear washer and grip sleeve that support the bulb sleeve, bearing washer that secures the grip range, core pin with a special trapezoidal screw and nut.

Figure 1 Components of High Strength One-Side Bolt

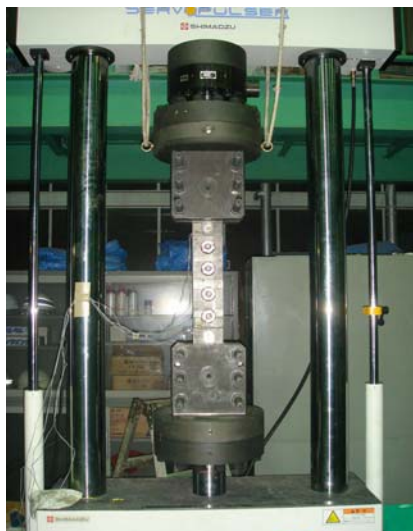
Three sets of specimens (M1, M2 and M3) were developed simulating the connection created by double friction (Figure 4). The bolt-hole had a diameter of 26.0 mm. Shot blasting was applied on the friction surface of the base material and splice. A strain gauge was installed 215 mm from the end of the base material, and the stress to be applied in the fatigue experiment was measured in static loading tests. The “Fatigue Design Guidance for Steel Highway Bridges”[7] specifies class B for the strength of high-strength bolted friction joints and a base stress range of 155 MPa. In the tests, however, stress grade was raised to class A and the stress range was set to be 190 MPa because comparison was made in fatigue strength between HOB friction joints and conventional high-strength bolted friction joints. In the fatigue experiment, an electro-hydraulic servo testing machine of Meisei University (Photograph 1) was used for pulsating

tensile fatigue experiment. Tension was applied cyclically at a rate of 6 Hz. Tests were repeated until the fracture of the base material with the maximum number of cycles set at 10 million times. The mechanical properties of steel plates are listed in Table 4. The materials of HOB and the mechanical properties of core pin are shown in Tables 5 and 6, respectively.

Photograph 1 Fatigue experiment

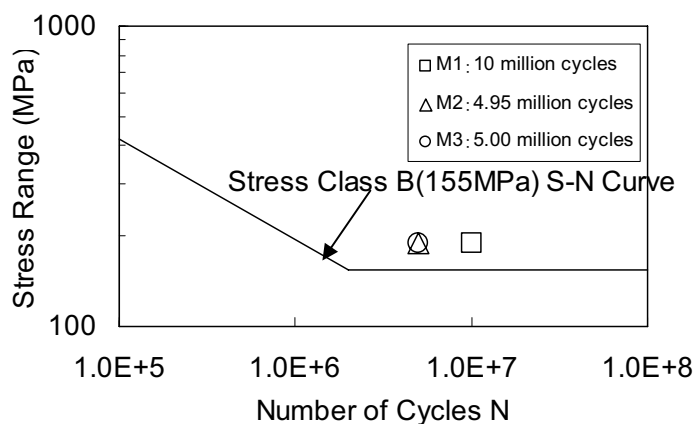
Figure 6 shows the results of fatigue experiments for HOB friction joints. The figure shows an S-N curve (strength class

B) for conventional high-strength bolted friction joints presented in the “Fatigue Design Guidance for Steel Highway Bridges”[7] .

Figure 6 Fatigue experiment results

The stress range for high-strength bolted friction joints was calculated using a formula specified in the “Fatigue Design Guidance for Steel Highway Bridges” [7]. The result was 190 MPa at strength class A, approximately 1.8 times 155 MPa at strength class B. The number of cycles for a stress range of 190 MPa was more than 2.5 times two million times, the fatigue limit. The results have revealed that HOB friction joints have fatigue strength to greater than that of standard high-strength bolted joints [7].

(3) The number of loading cycles for a stress range 1.8 times the stress range for high-strength bolted joints was five million, more than 2.5 times two million, the fatigue limit. HOB friction joints have fatigue design curve to conventional high-strength bolted joints

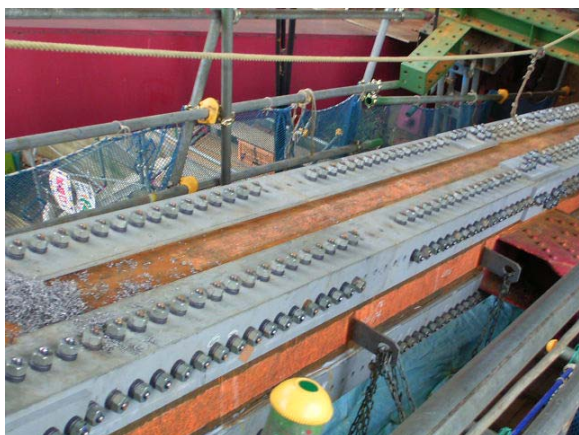
HOB have been frequently used for repairing or strengthening steel highway bridges under construction constraints. In recent years, HOB have been adopted in an increasing number of cases for seismic retrofit of relatively large bridges such as arch and truss bridges. The example is the seismic retrofit of the corner of an arch rib [1], [4] (Photograph 2) and Photograph 3.

Photograph 2 Strengthening a steel arch bridge

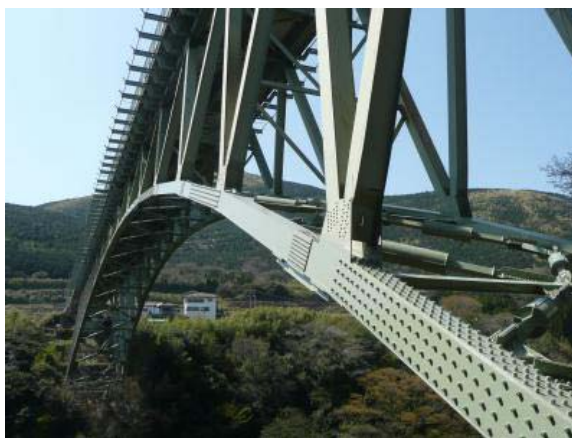
Photograph 3 Strengthening a steel arch bridge

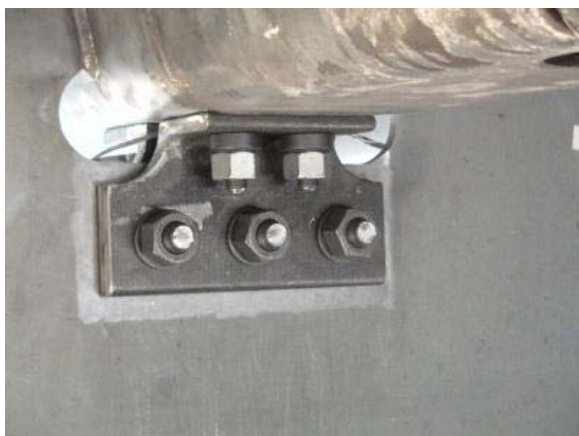
Recent works also present case studies of adoption of HOB for strengthen against fatigue cracking at intersection of the U-shaped and transverse ribs of a steel slab [9]. An example of connecting a reinforcing member on the bottom surface of a U-shaped rib of a steel slab using HOB is shown in Photograph 4, and strengthen a steel pipe piar Photograph 5.

Photograph 4 Strengthening a steel slab U rib

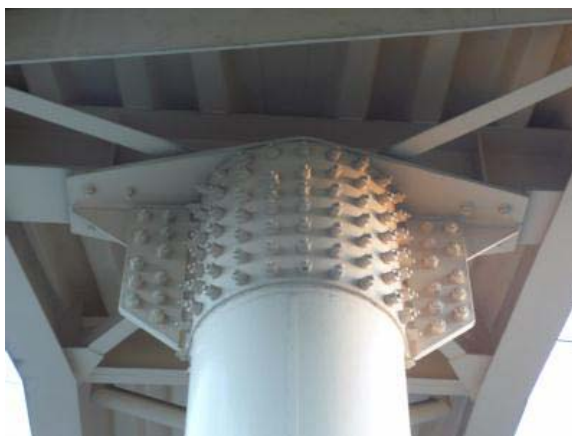
Photograph 5 Strengthening a steel pipe piar
